The Henking and Drummond family of Woodruff

Teacher slays dinosaur propane furnace in home built by her grandfather

Home Energy Efficiency Makeover

Eric Henking, Melissa Drummond & sons, Woodruff, SC

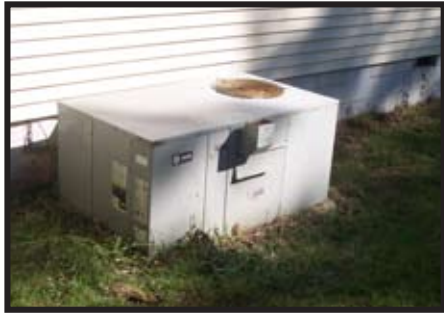
BEFORE

The home’s combined propane furnace and electric air conditioner unit was 20 years old, costly to operate and an inefficient solution to heating and cooling.

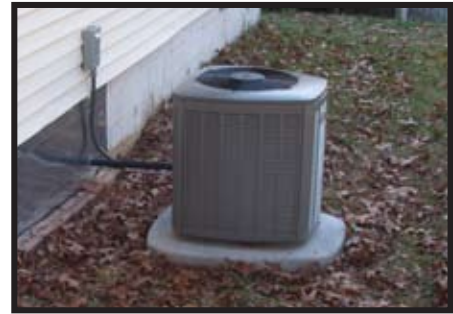
AFTER

Davis Services installed a two-ton, 15 SEER Lennox heat pump split system, dramatically improving comfort and energy savings in the home.

- Davis Services replaced the 20 year-old, 3-ton combination propane furnace and electric air conditioner unit located outside the home with a 2-ton SEER 15 Lennox heat pump split system. The smaller capacity system was made possible because of the improved insulation and ductwork significantly reduced the home's heating and cooling needs.
- A manual thermostat was replaced with a programmable thermostat.

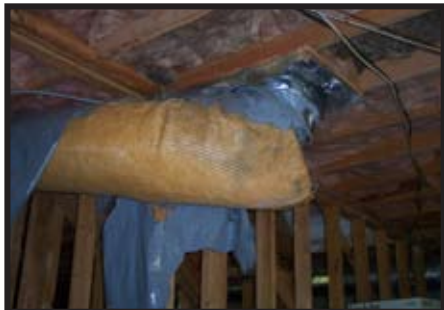
Poorly wrapped and insulated ductwork was leaking conditioned air in the basement and crawlspace. The leaks made the entire system much less efficient—and wasted money.

- Davis Services replaced almost all of the existing flexible ductwork with a system that included hard metal trunk with all seams sealed with mastic paste and flexible duct to each room that was no more than 10-feet in length. As a result, duct air leakage was reduced by 83 percent — from 300CFM to 50 CFM — exceeding the ENERGY STAR standard.
- Davis Services constructed a new return duct system to improve air flow.

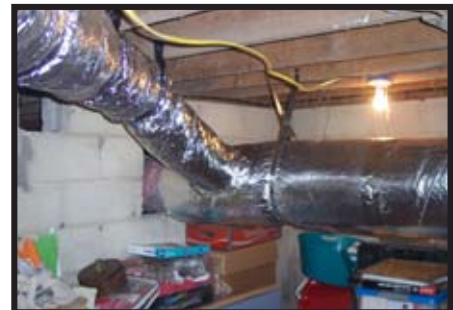
A new system of sealed and insulated ducts replaced the old setup. Now warm or cool air leaving the family’s new HVAC unit flows efficiently throughout the home.

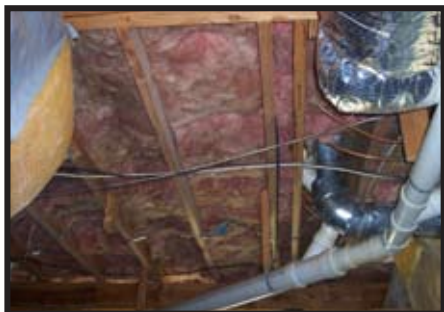
As with many homes, insulation in Eric and Melissa’s attic, basement and crawlspace was inadequate, having settled or deteriorated over time. Those problems compromised the home’s protective barrier against extreme hot and cold outside temperatures.

- In the attic, Glenco Foam replaced the 3.5 inch fiberglass batts on the attic floor, rated at R-13 efficiency, with 5.5 inches of Icynene spray foam insulation under the roof deck equivalent to R-20 and 3.5 inches of foam at the roof gable ends equivalent to R-13. The attic area now meets the building code for today's construction.

- In the basement and crawlspace, the ceiling above these unconditioned areas, where there was no insulation, Glenco Foam sprayed 3.5 inches of icynene foam which also sealed electrical/plumbing penetrations and formed an air barrier for the conditioned living space above.

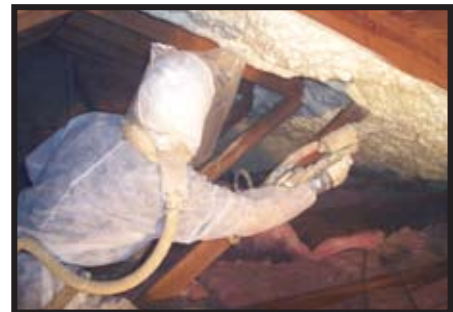
Glenco Foam applied Icynene foam under the attic roof deck and on unconditioned areas in the basement and crawlspace. They also sealed electrical/plumbing penetrations, forming an effective air barrier for the home.
