Butler family of St. Matthews

Chimney steals energy savings

Home Energy Efficiency Makeover

Linda Butler's home, St. Matthews, SC

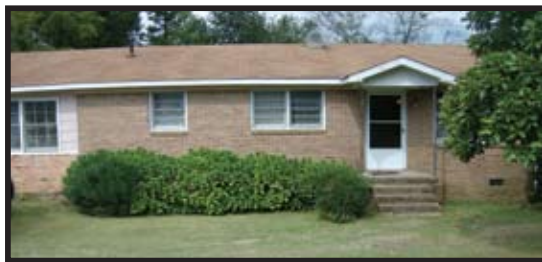
Tests showed the house was five times as drafty as it should be if it were properly air sealed. The main source of the air leaks was a wood stove chimney that was no longer in use. The stove pipe had been plugged with newspaper, but the attic and wall space around the chimney was open.

- Comfort Services sealed the chimney in a way that it could be reopened if the family decided to use it again.
- Evans Construction Group of Orangeburg replaced the warped windows that could not be fully closed. They caulked around windows, doors and the brick hearth, and patched a hole in the brick wall where the flue for the wood burning stove was removed.
